**City of Miami
Marine Stadium
At
Virginia Key**

Existing Building Condition Assessment

Project No.: F008449.00

July 21st, 2008

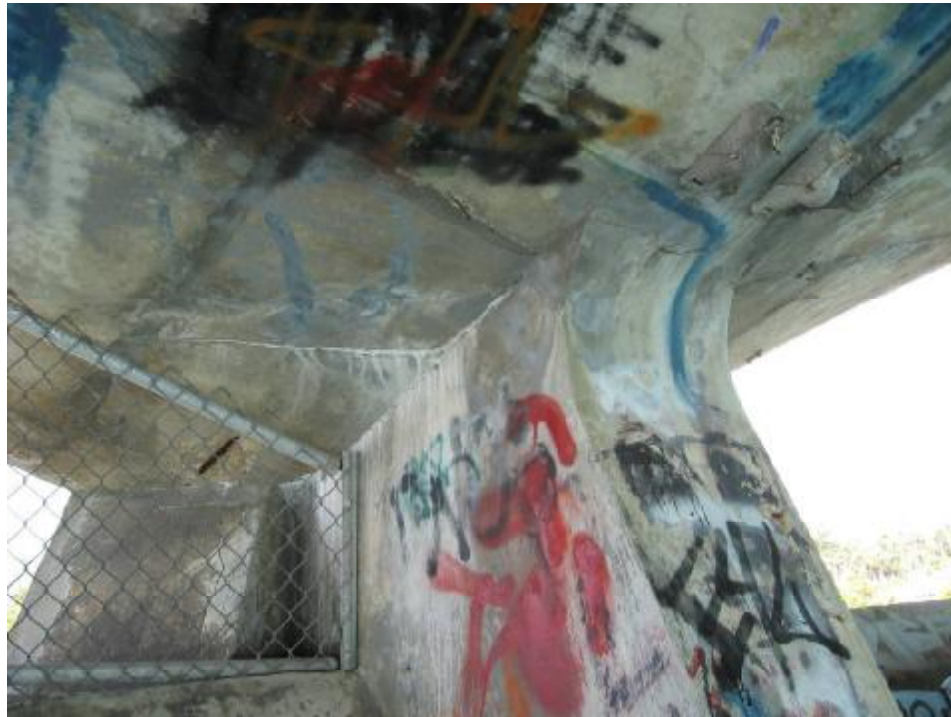
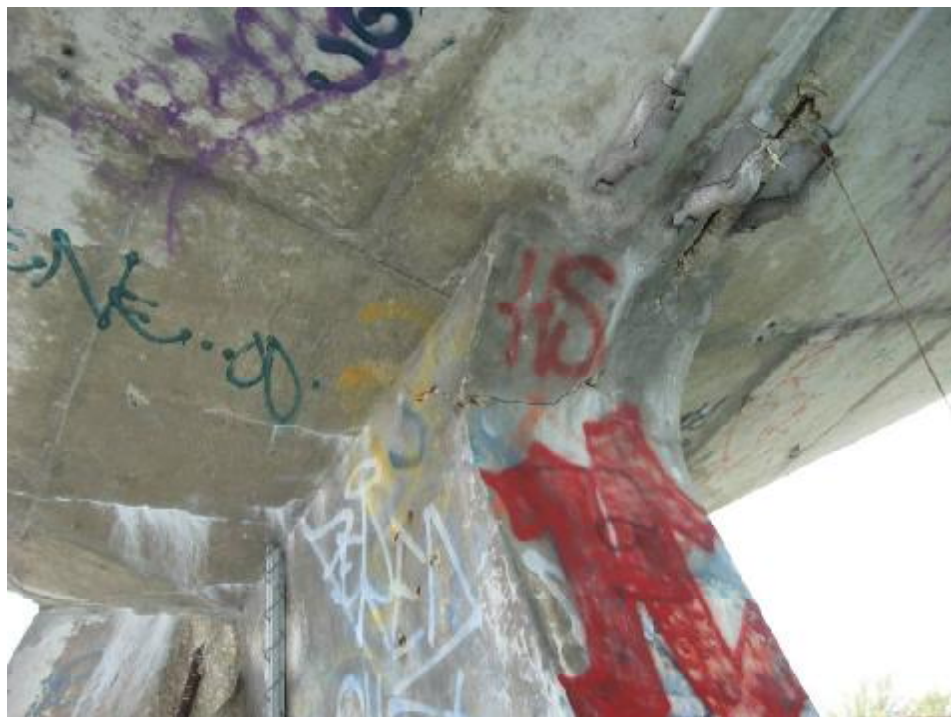
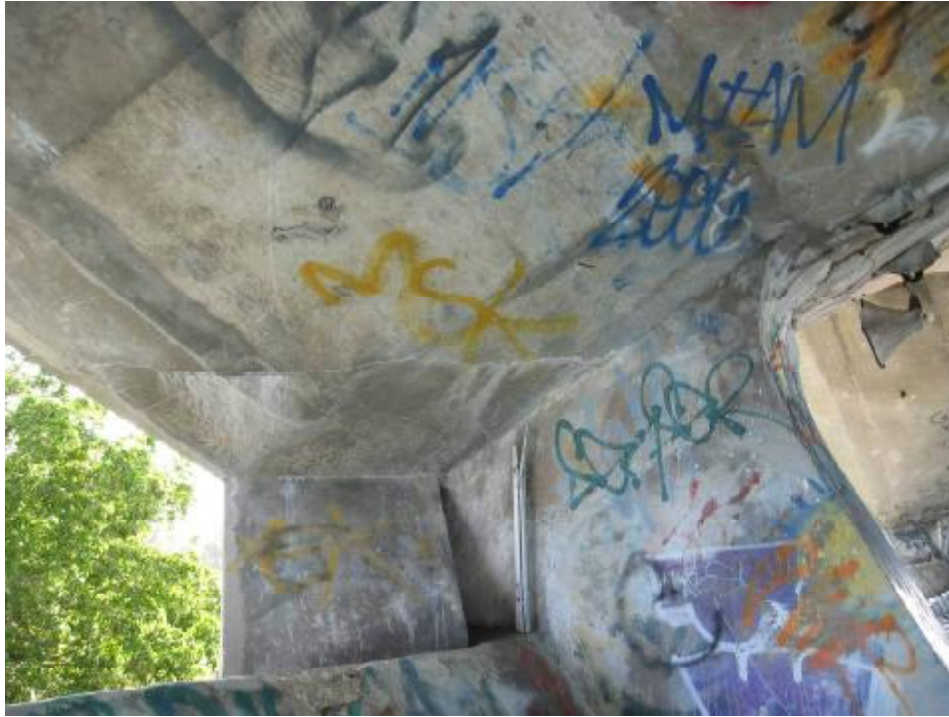
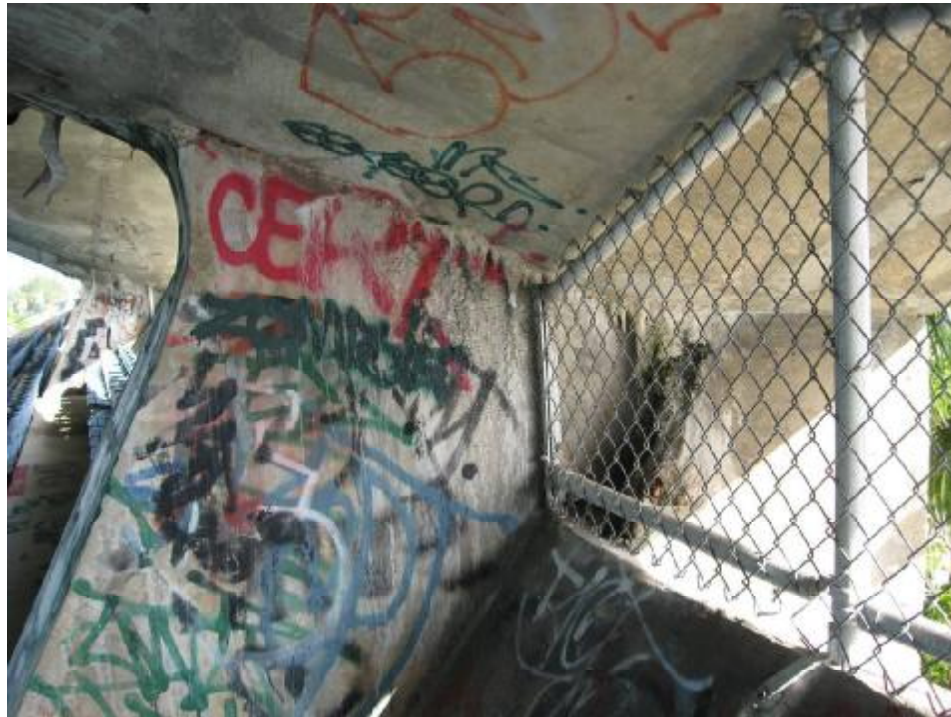
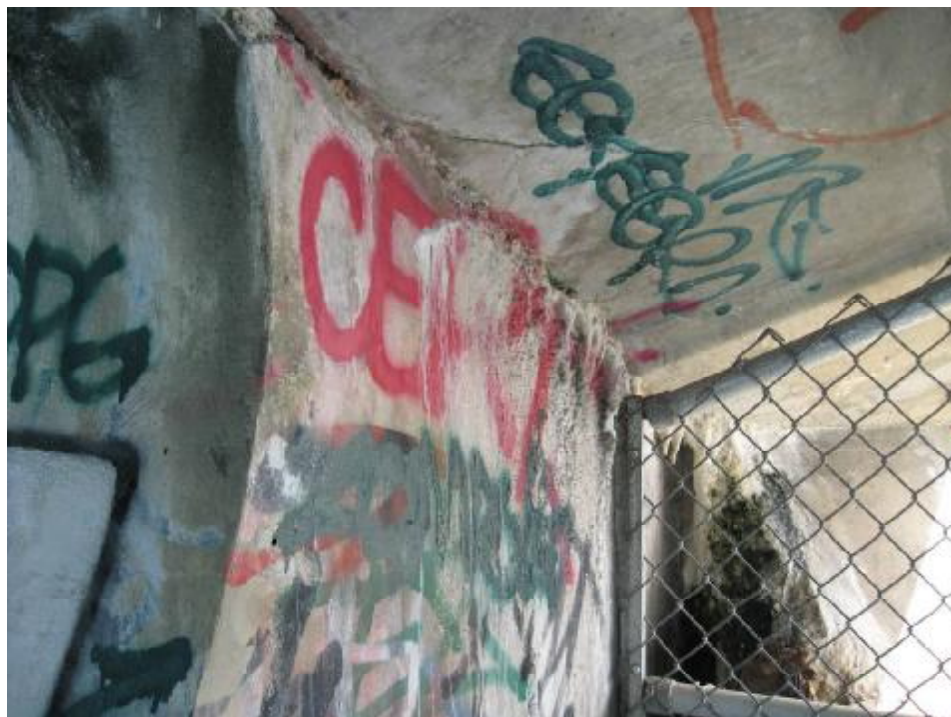
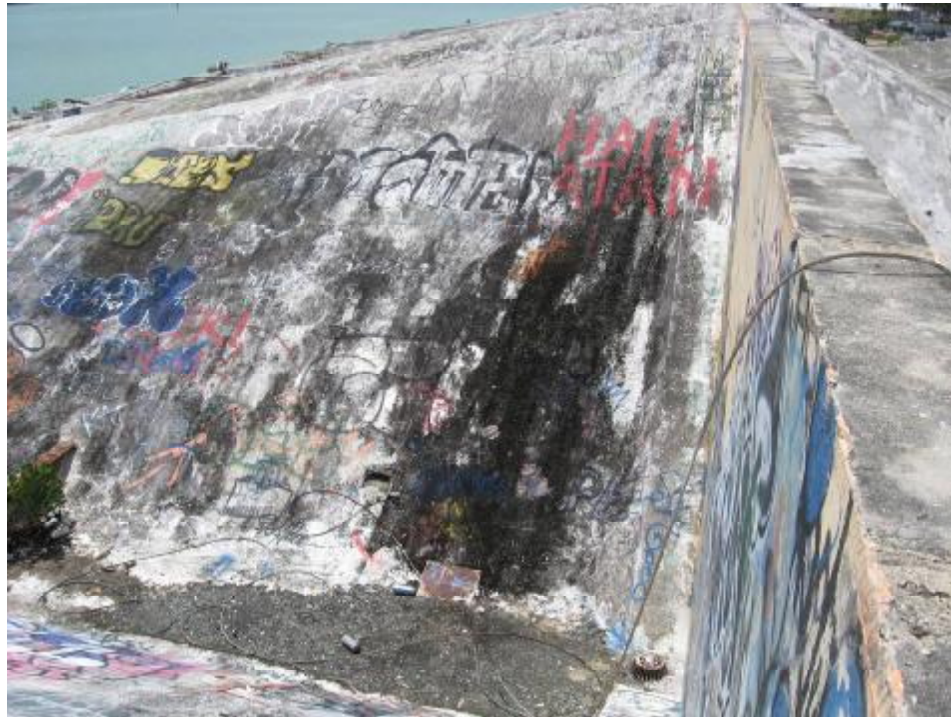
There is a semi-circular crack in the roof slab that radiates from both sides of the upturned portion of the raker. There is also exposed, corroded rebar and spalled concrete, along with the presence of white efflorescence, indicating water is leaking into this joint (Photo 104, 105, 106, 107, 108, 109, 110). Water is most likely entering through the construction joint that is located in the ridge of the V-shaped roof and located over the support.

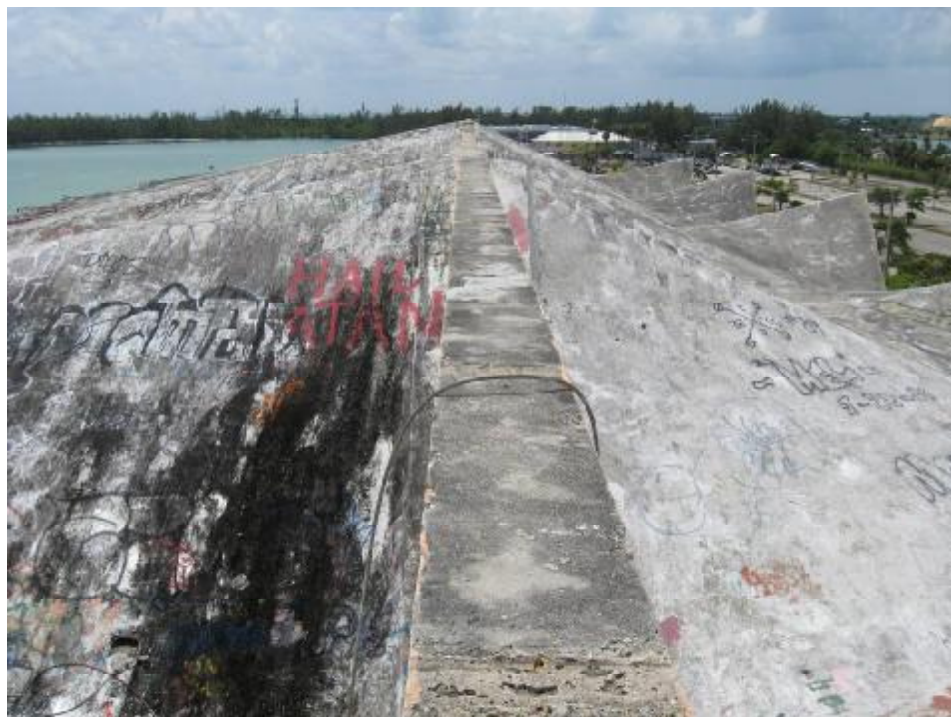
Photo 112

There is very little remaining of a roofing membrane on the topside of the roof slab, which has left the concrete surface exposed in most of the roof area (Photo 111, 112, 113, 114, 116, 118). The roofing membrane requires replacement.

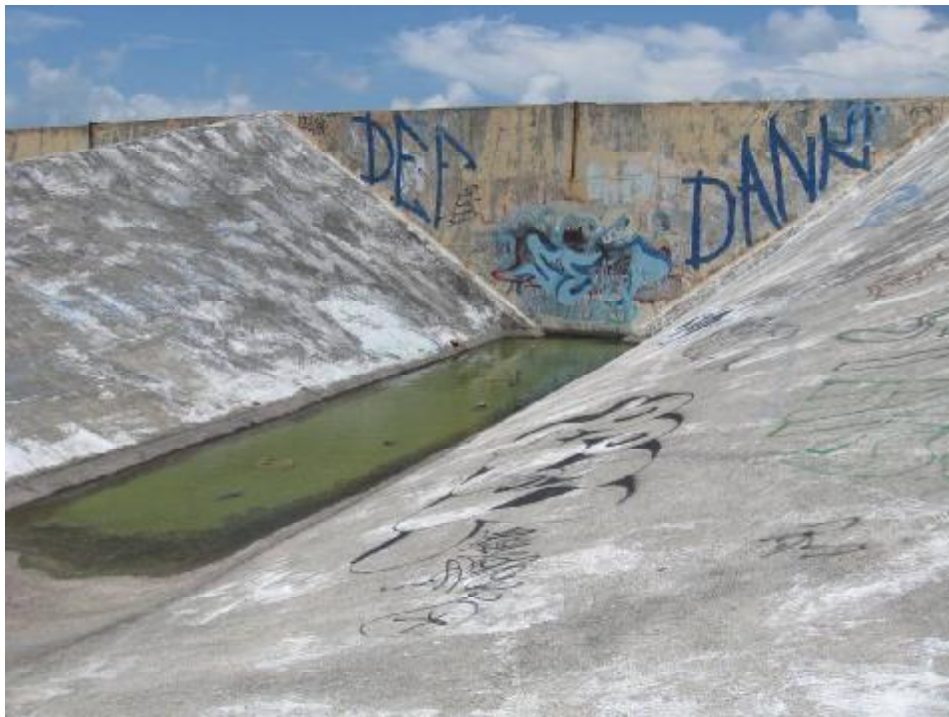
Photo 114

The valleys appear to be drained by a roof drain located over the main interior column. Only 2 of the 8 drains are operable and there is standing water approximately 16" high, which is up to the overflow scuppers in 6 of the valleys (Photo 114, 115).

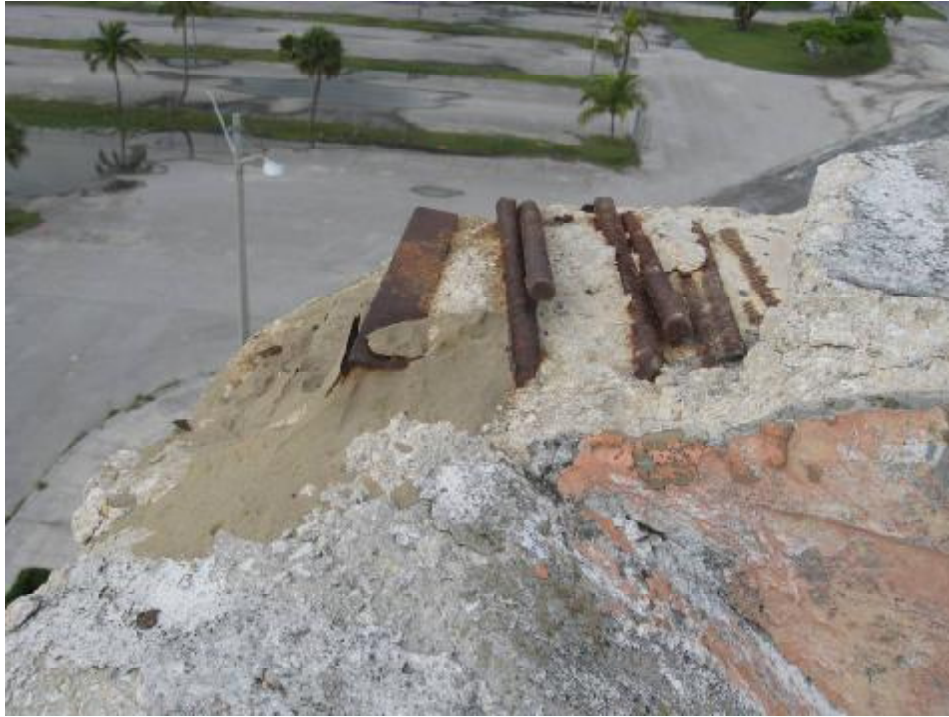
Photo 117

There is minor cracking in the 12" thick wall that is located over the main interior columns separating the cantilever and the rear portion of the roof structure. At the east end of the wall the concrete has spalled away exposing rebar and the anchors for the post tensioning cables (Photo 117).

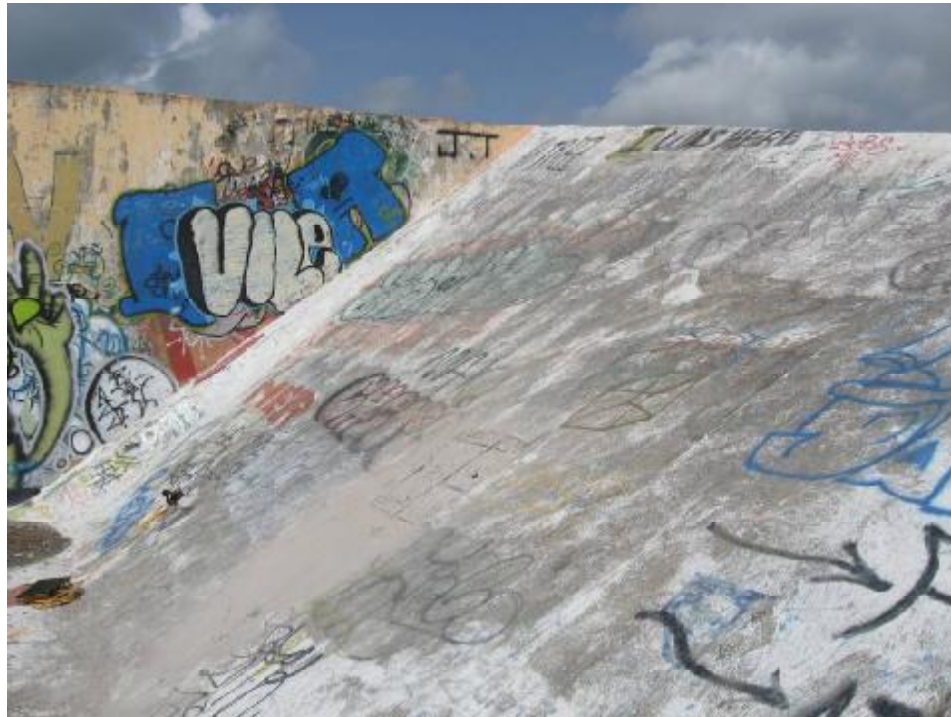
Photo 119

The first location was in the west side of the V-shape on grid line 6 (Photo 119). This location was chosen because of the functioning drain in this valley which would allow workman to operate their electric tools safely without being in standing water. The opening was located approximately 6 feet diagonally up from the scupper drain in an area with diagonal cracks. A 30" x 30" area of concrete was removed to expose the reinforcing bars (Photo 120). The slab is 3" thick and there was a 1/2" of concrete cover over the top layer of bars. We found the reinforcing to be a single layer of #4 bars at 12" centers in each direction. The direction of the bars was parallel and perpendicular to valley and ridge. The bars were galvanized. There was no visible corrosion in the rebar (Photo 121).

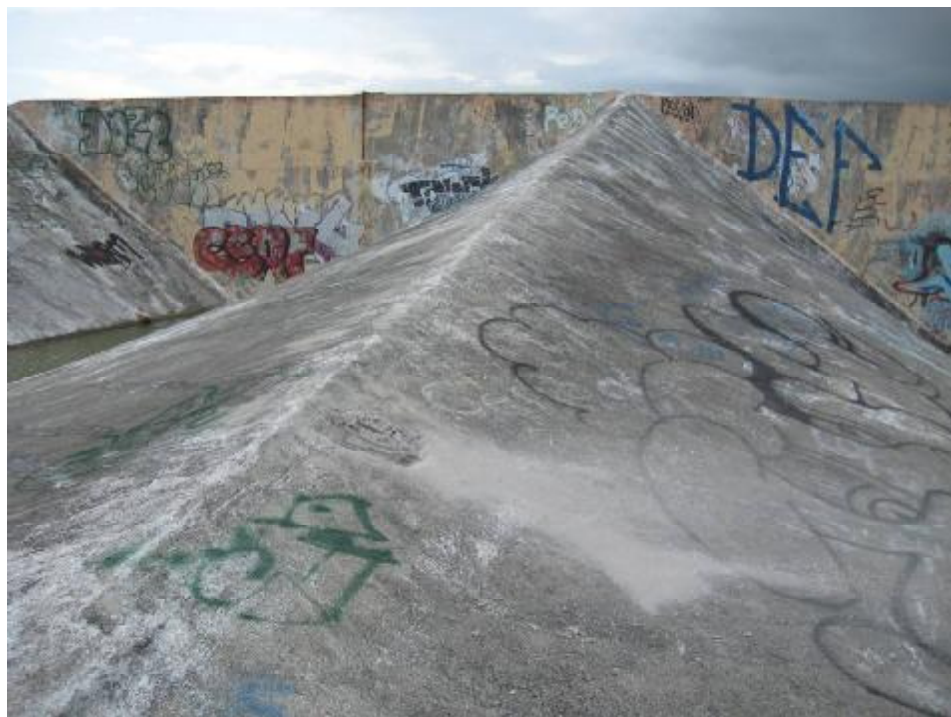
Photo 122

The second and third locations were located at different elevations on the ridge of the V-shape (Photo 122, 124) where concrete was removed to uncover a concentration of #9 bars that were contained in closed #3 ties (Photo 123, 125). There was no visible corrosion in the bars, except mild corrosion was found on some of the ties where there was little or no concrete cover.
